CUSTOMER SUCCESS STORY

SOLUTION : BRELKO BELT HEAD PULLEY and SECONDARY SCRAPERS.

LOCATION : TRONOX NAMAKWA SANDS, BRAND-SE-BAAI, 385KM NORTH OF CAPE TOWN, SOUTH AFRICA.

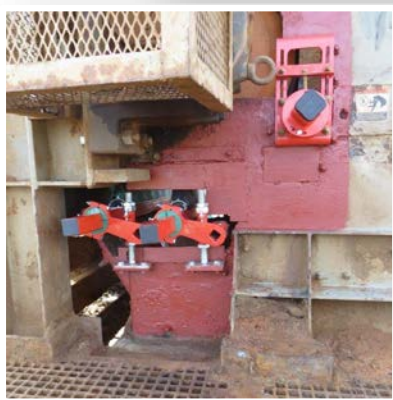
Results of the project showed great improvement. Plant personnel report that the conveyor belt cleaning has improved and that material carry-back and spillage were almost completely eliminated. Plant personnel consider the installation as "money well spent" and...

To reduce spillage and material carry-back, BRELKO installed 1x E951-TT Composite Ceramic Multi-blade Head Pulley Belt Scraper and 2x E205-T Multi-blade Secondary Belt Scrapers with T3 tungsten tips and Brelko's patented Torsion Mountings to compensate for the different belt thicknesses on the Drive - C conveyor belts head/discharge chute.
